Photos taken November 3, 2006 under mussel rafts in Gallagher Cove during dive commissioned by APHETI, a citizen group. See page 2 for dive details.

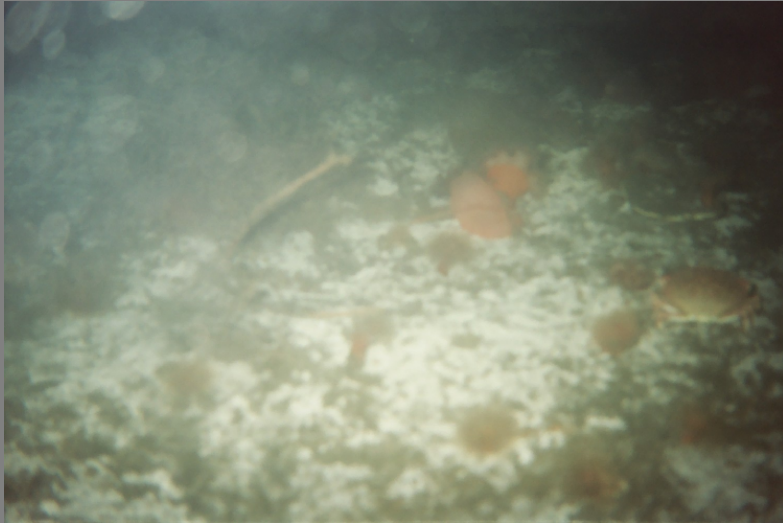
Beggiatoa bacteria growing in white mats under mussel rafts.

Excerpt from email letter from Prof. Joel Elliot, University of Puget Sound:
“...it is clear that one of your samples had a lot of Beggiatoa in it...as for the sediment from the sample with all of the Beggiatoa, there was a high concentration of hydrogen sulfide in the porewater as you know from the rotten egg smell. This is consistent with the conditions where you find the growth of surface mats of Beggiatoa.” 11/9/06

***WHITE MATTING (BEGGIATOA?) SPREAD OVER ENTIRE AREA**

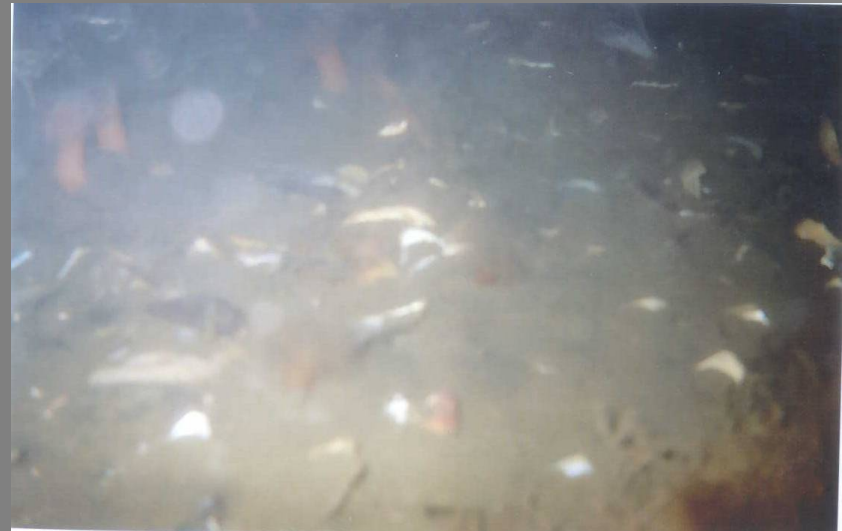
Miscellaneous debris under mussel rafts – 'dead zone.'

***ENTIRE AREA COVERED MUSSEL SHELL DEBRIS**

***SCATTERED SPREAD, SHEET METAL, PVC, OTHER DEBRIS**

*** BENTHIC LAYER UNDER RAFTS & SURROUND APPEARS SIGNIFICANTLY COMPROMISED – DIVERS SAID AREA LOOKED LIKE A DEAD ZONE.**

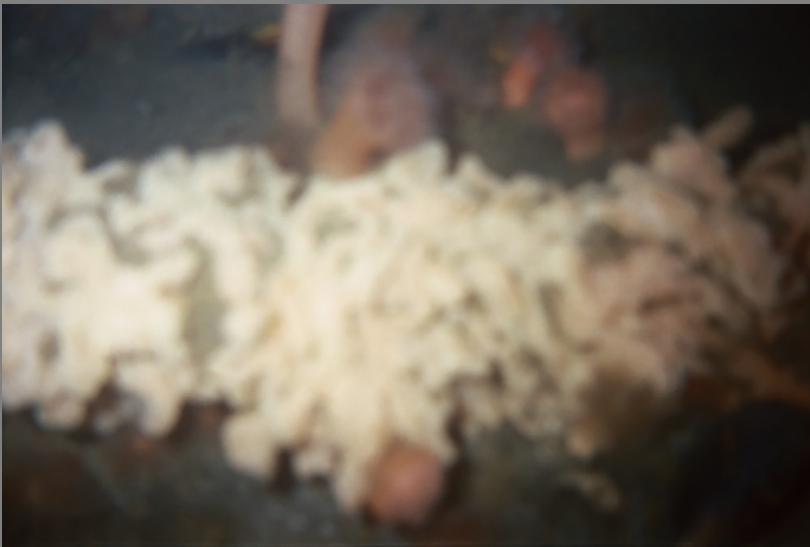
Clumps of tunicates under mussel rafts.

***3 WHITE CLUMPS (AGGRESSIVE COLONIAL TUNICATE?)**

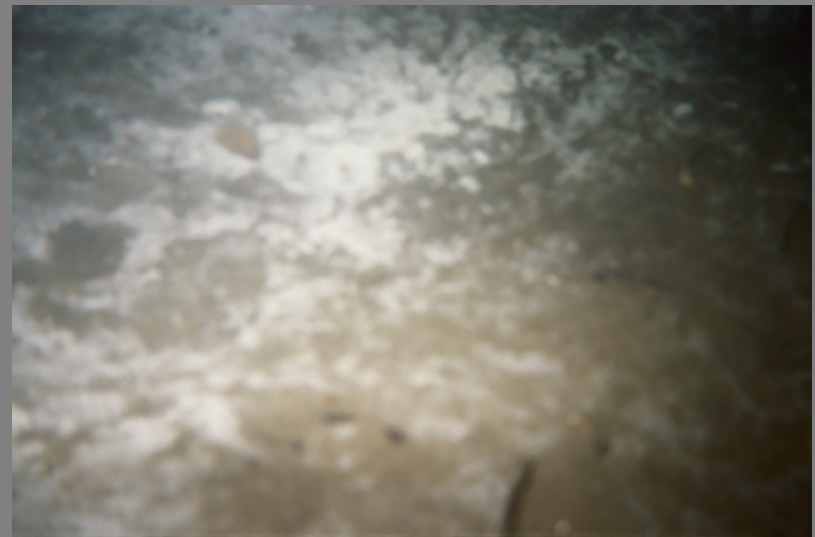
Beggiatoa mats under mussel rafts.
